**FORMAL INVESTIGATION INTO THE CIRCUMSTANCES SURROUNDING THE
ALLISION BETWEEN THE BARGE TOW OF THE M/V BROWN WATER V AND
THE QUEEN ISABELLA CAUSEWAY BRIDGE ON SEPTEMBER 15, 2001, IN PORT
ISABEL, TEXAS, RESULTING IN MULTIPLE LOSS OF LIFE**

ACTION BY THE COMMANDANT

**INVESTIGATION REPORT INTO THE CIRCUMSTANCES SURROUNDING
THE ALLISION BETWEEN THE BARGE TOW OF THE M/V *BROWN WATER*
V AND THE QUEEN ISABELLA CAUSEWAY BRIDGE, TEXAS, ON 15
SEPTEMBER 2001, RESULTING IN MULTIPLE LOSS OF LIFE**

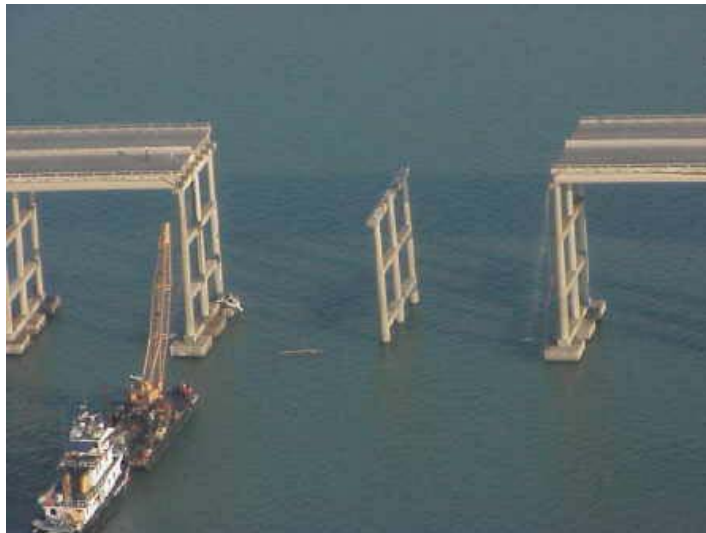
At or near 2110 on Friday, September 14, 2001, the M/V *Brown Water V* departed Brownsville, Texas, under the control of Captain Rocky Lee Wilson. The *Brown Water V* was pushing four loaded hopper barges ahead of it, lined up in a straight line, single-file. At 2400 Captain David D. Fowler took the helm. The vessel successfully cleared the Long Island Swing Bridge at 0145 on September 15, and at 0200 allided almost head-on with the Queen Isabella Causeway Bridge approximately 375 feet west of the channel. The Queen Isabella Causeway Bridge connects Port Isabel with South Padre Island. The allision caused two 80-foot sections of the bridge to collapse. Following the collapse, nine vehicles entered the water through the missing bridge sections, resulting in eight deaths and three injuries.

The bridge with two sections collapsed

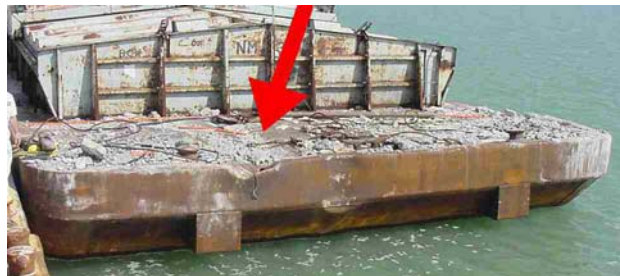
There was some damage to the alliding barge but no flooding.

Damage to barge

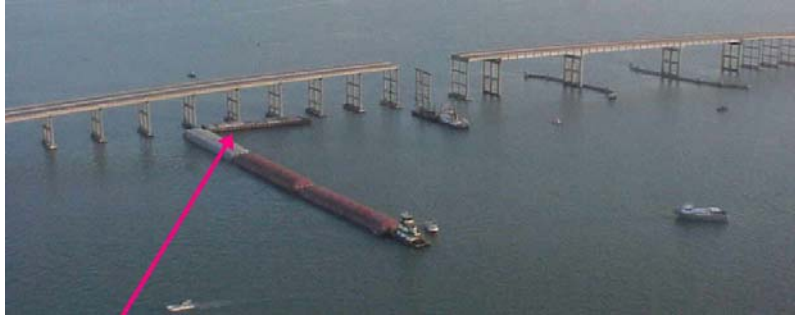
The coupling connecting the lead barge to the second barge was either snapped by the allision or snapped following the allision due to the current pushing the vessel and tow to the west of the allision point.

*Vessel and barge configuration following the allision,
lead barge decoupled*

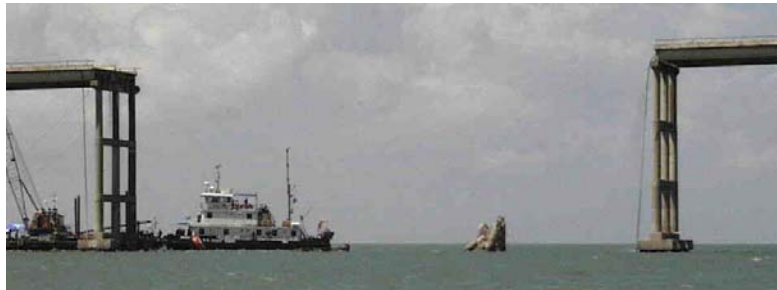
Later that day, during the search and rescue operation, a third 80-foot section of the bridge collapsed but caused no injuries or deaths.

The bridge with three sections collapsed

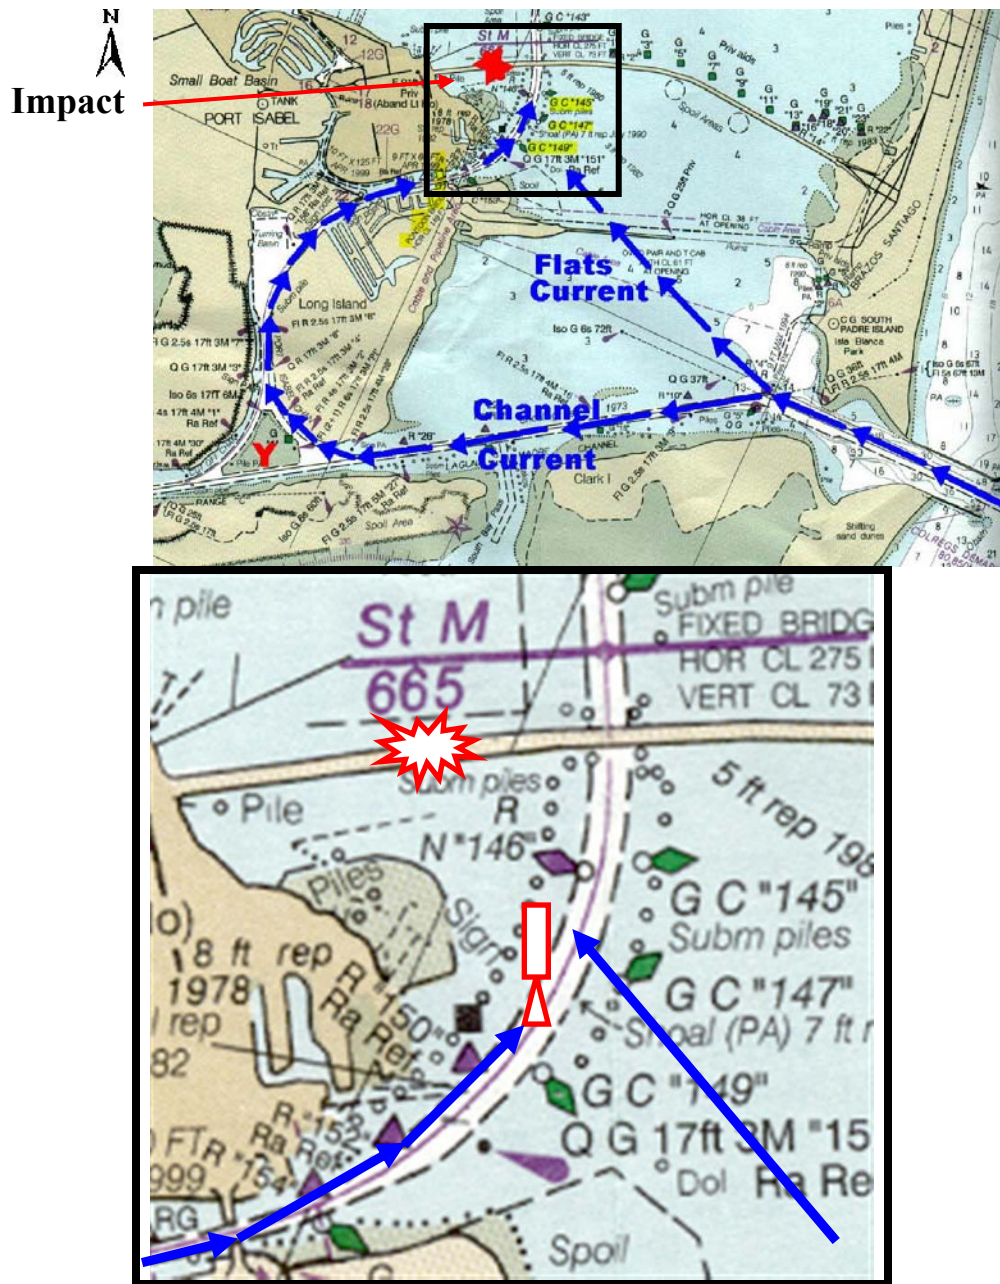
As the head of the tow passed Long Island and neared aid 149, the flats current began working on it. The vessel and tow were now being affected by two separate currents -- a channel current pushing the stern of the tow from behind in a northeast direction, and a flats crosscurrent pushing the head barge northwest. As the 851-foot long vessel and tow configuration continued past Long Island and further into the flats crosscurrent, more of the configuration was affected, and the head of the tow began swinging to port. The head of the tow continued swinging northwest in response to the increasing effect of the flats crosscurrent, while the stern of the towboat continued to be pushed northeast by the channel current. This swinging action pivoted the stern of the *Brown Water V* into the

shallows on the east side of the channel near aid 149. Whether or not the towboat bumped bottom, this pivoting action had taken control of the configuration and the flats crosscurrent swept the configuration west, out of the channel and into the bridge.

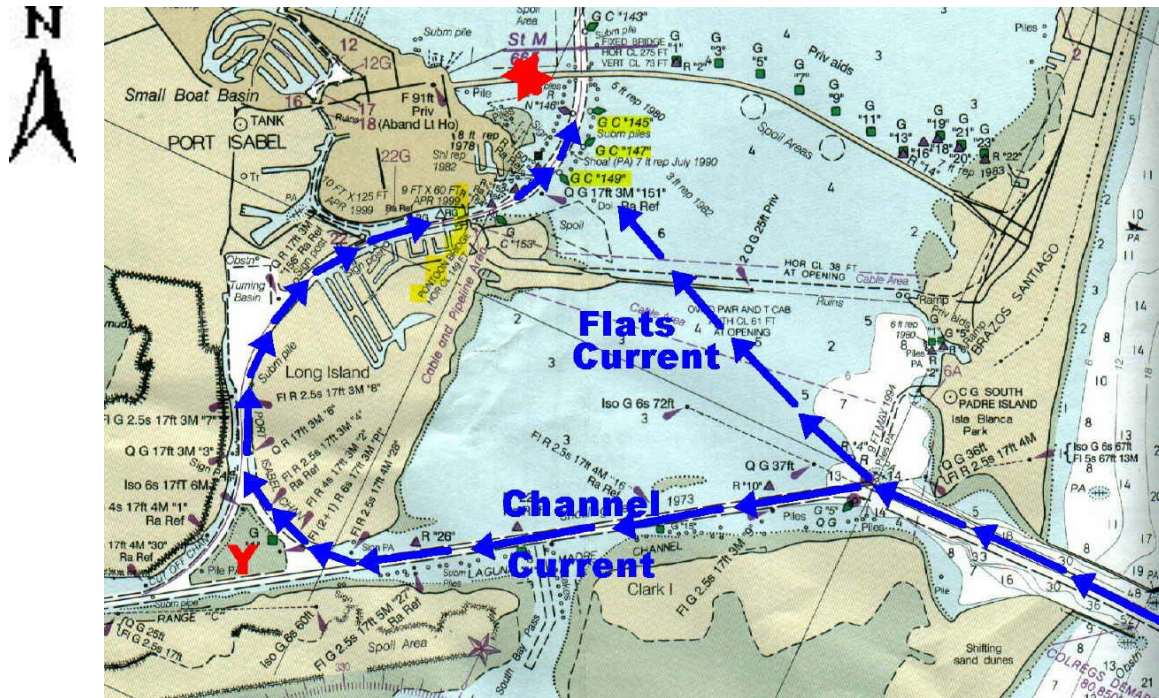
As the head of the tow passed Long Island and the spoil area east of the island and neared aid 149, the flats current began working on it. The vessel and tow were now being affected by two separate currents -- a hard running channel current pushing the entire configuration northeast and a flats current pushing the head barge northwest. As the 851-foot long vessel and tow configuration sailed past the current-sheltering island and spoil area, the inrushing flats crosscurrent increased its effect, and the head of the tow began swinging to the port. Because Captain Fowler was not aware of the crosscurrent and had not "set up for it," the converging currents overwhelmed the configuration.

The head of the tow continued swinging northwest in response to the increasing effect of the flats crosscurrent, while the stern of the towboat continued to be pushed northeast by the channel current. This swinging action may have pivoted the stern of the *Brown Water V* into the shallows on the east side of the channel near aid 149, and the stern of the vessel may have bumped bottom. Whether or not the towboat bumped bottom, the configuration was past the point-of-no-return when Captain Fowler failed to set up for the flats current as he exited the Long Island Swing Bridge. The vessel and its tow were swept west of the channel and into the bridge.

Captain Fowler stated that he was in the channel when he bumped bottom. If the *Brown Water V* bumped bottom, the vessel was not in the channel at the time. The *Brown Water V*'s draft was 8' 6", and there was no place in the channel that was less than 12 feet deep. It is likely when Captain Fowler stated he was in the channel, he meant he was between the red and the green aids to navigation. The red and green aids to navigation do not define the edge of the channel.
